ADDERBURY PARISH COUNCIL

Milton Road – Proposed natural turf pitch

Key Stage Inspection

Report Date: 12th June 2020
Consultant: Michael Boyes

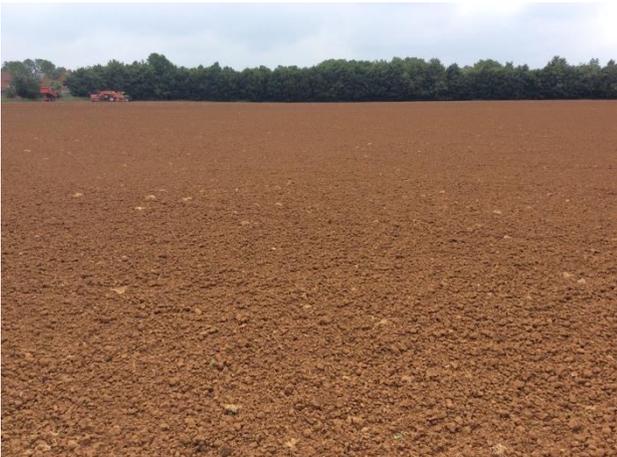
<p>Figure 1: General cultivation and rough levelling is acceptable across the vast majority of the section of the site which has been allocated for the establishment of natural turf pitches (North to South orientation shown above).</p>	<p>Figure 2: Sub surface cultivation on the east boundary of the site revealed the extent of recent satisfactory rotovation operations.</p>

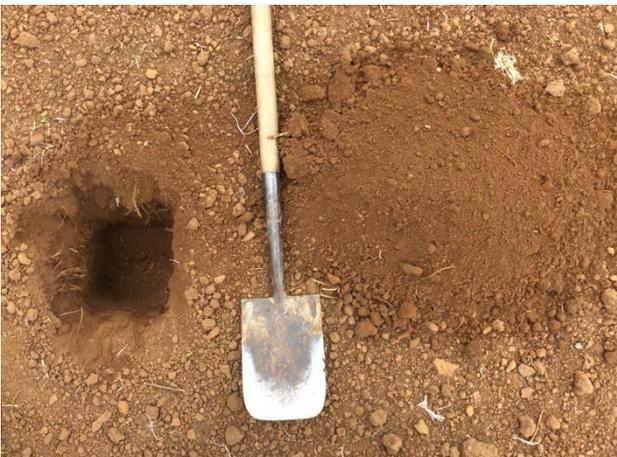
<p>Figure 3: The east side of the site also illustrated the finer tilth achieved through appropriate levels of cultivation.</p>	<p>Figure 4: The west boundary was less positive with large aggregates still evident, fairly shallow within the soil profile. A further final cultivation operation is highly recommended.</p>

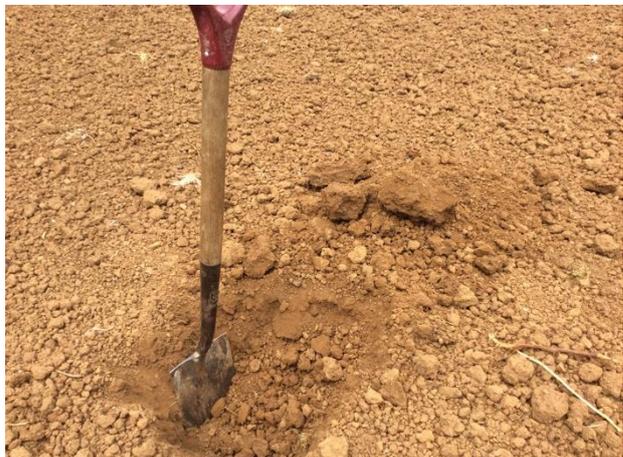
- A natural gradient is evident towards the north eastern corner of the field.
- Soil pit inspection revealed that soil cultivation was marginally inconsistent across the area with a more friable profile evident towards the eastern side of the field with a finer soil tilth whereas larger soil aggregates were apparent within the profile and at the surface on the western boundary of the area.

- Undertake final rotovator operation to ensure appropriate cultivation of sub-soils across the area of the site designated for natural sports pitches and recreational use.

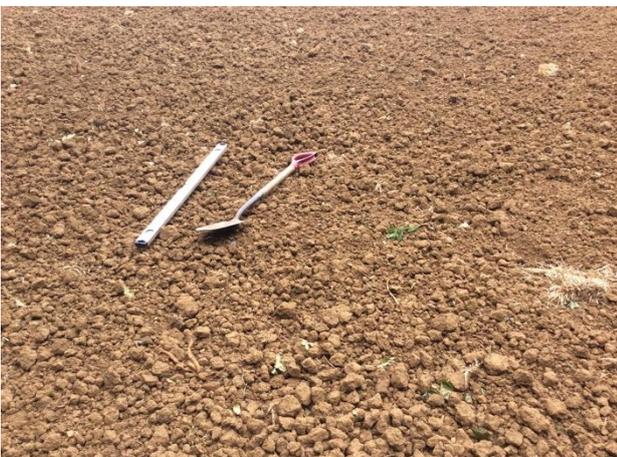
<p>Figure 5: Larger aggregates were also apparent at the surface in the NW corner of the area allocated for pitch development emphasising the need for further rotation and levelling works prior to drainage installation.</p>	<p>Figure 6: A natural fall was apparent from South to North as shown on the eastern boundary above which will aid drainage of the site.</p>

- Conduct final rough grading operation with tractor-mounted levelling bar to redistribute cultivated soils, disperse larger aggregates at the surface, correct the identified low areas, achieve appropriate consolidation and establish suitable surface levels for drainage installation.

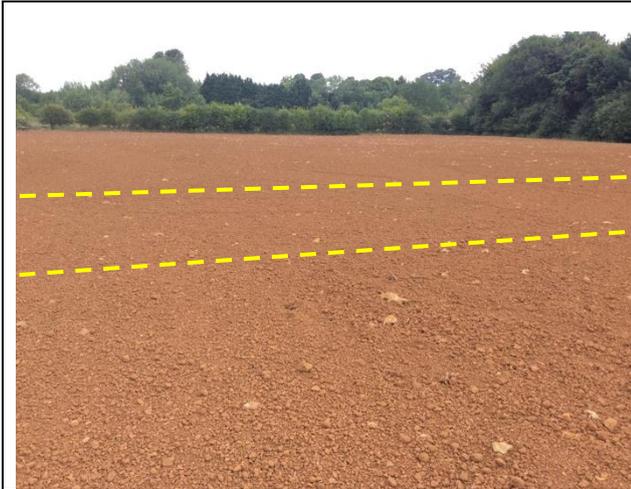
- Site consolidation and general surface levels were noted to be acceptable across the vast majority of the site allocated for establishment of a natural turf area for recreational use and amateur sport pitches. A slight depression was evident to the naked eye through the centre of the field from West to East. Sport England tolerances for final surface levels (i.e. +/- 20mm across a 3m straight edge) are not currently being met but are not required at this point to carry out installation of the drainage and will become more pertinent in the preparation of final levels and seedbed.

Figure 7: A slight was evident through the centre of the site for pitches from West to East, particularly towards the eastern boundary. Final cultivation and levelling should aim to correct this prior to drainage installation.

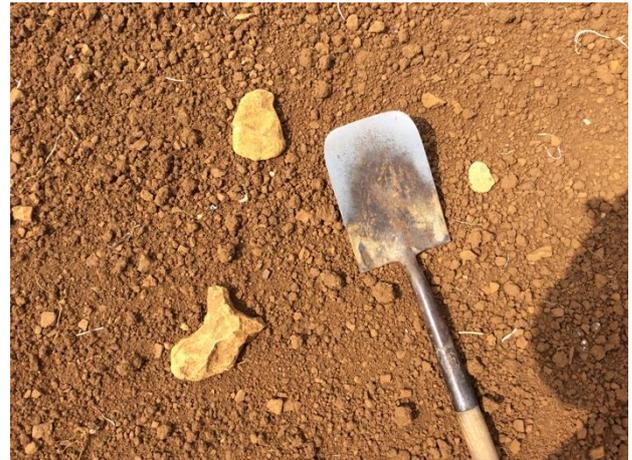
- Vegetative debris and some large stones were apparent across the site and will require removal prior to the establishment of final surface levels but will not impede drainage installation.

Figure 8: Some stone picking will be required prior to seed bed preparation and final grading of levels for overseeding operations.

- Plan for stone and vegetative debris removal ahead of generation of finished levels.
- Make provision for final grading operations to establish desired surface levels and a fine soil tilth for over-seeding operations. Sport England tolerances for surface levels is 20mm over a 3m straight edge.

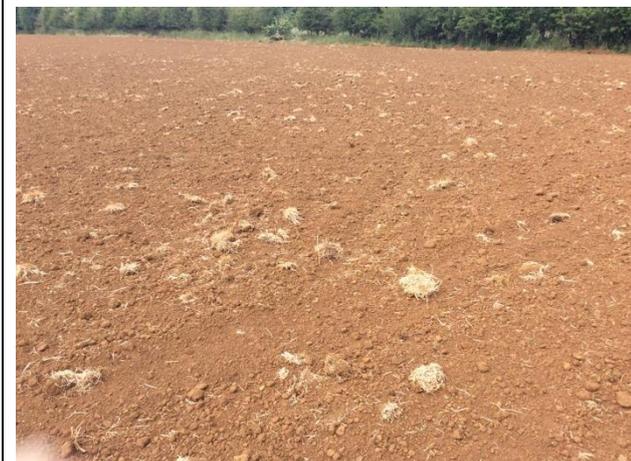
Figure 9: Vegetative debris will also need to be removed to ensure successful seed strike and sward establishment.

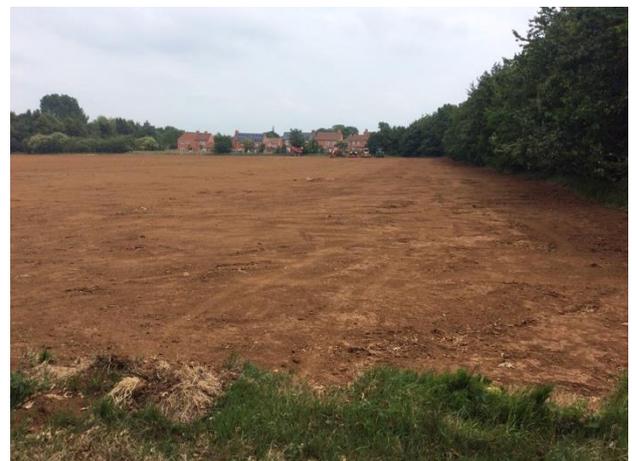
Figure 10: A section of the site immediately adjacent to the road at the south end of the field has been stripped, roughly graded and compacted in preparation for the construction of facilities and car-parking.

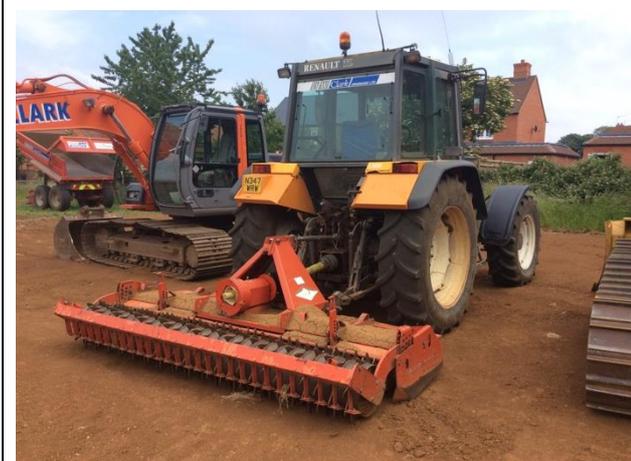
Figure 11: The drainage contractor has a number of key pieces of equipment on site to carry out final cultivation operations to break up the larger soil aggregates to promote a more friable profile and finer surface soil tilth.

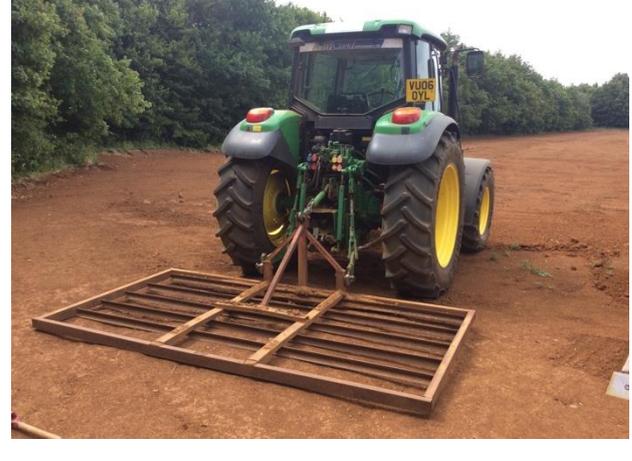
Figure 12: A final rough grading with the levelling bar will eradicate any surface imperfections and iron out the minor mounds and depressions detailed above.
