**Recommendations for the future management  
of Adderbury Lakes, Adderbury  
Undertaken by Windrush AEC Ltd, on behalf  
of Adderbury Parish Council and Lakes  
Management Committee**

This report is based on a site visit undertaken on 2 December 2019, in the company of Rick Atkinson and Nigel Claxton

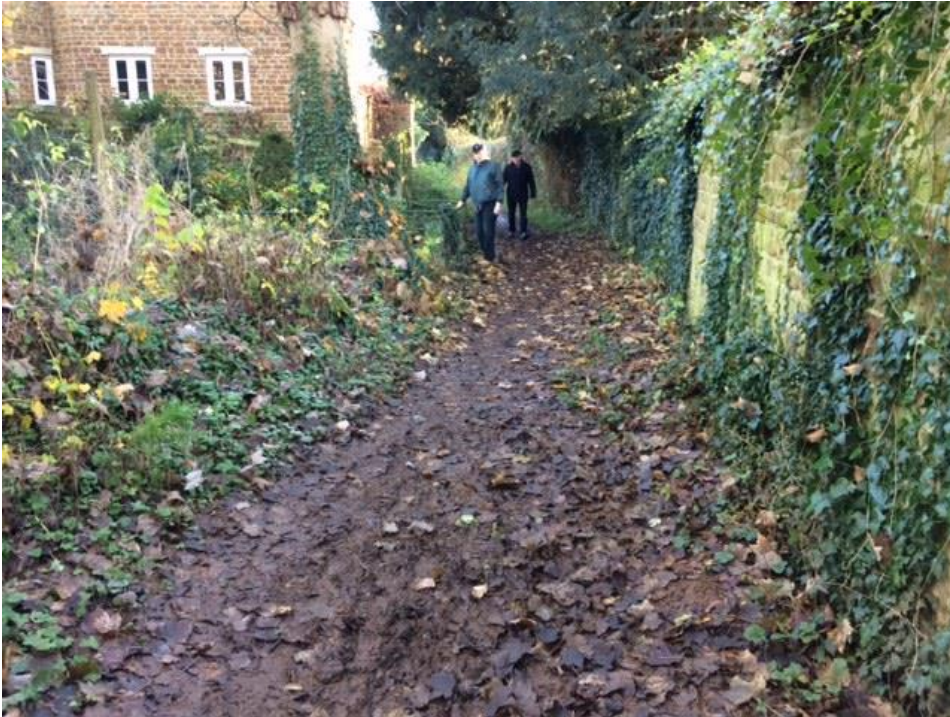
**Figure 1: Footpath above the lake which is the origin of past sewage spills**

Discussions with Rick and Nigel confirmed that there have been spills of sewage effluent from Thames Water (TW) assets that have entered the lake. The source of the effluent is believed to be one or more drain covers within the footpath upstream of the lakes. These surcharged during periods of heavy rain, causing effluent (presumably untreated) to enter the lake. This has apparently occurred on more than one occasion, with TW forced to send staff to clean up the spillage.

Despite the clean-up operation, it will be inevitable that a considerable amount of nutrients, particularly phosphorus will have entered the lake system. In addition, the suggestion was made that the large property on the western side of the lake has a septic tank system that may allow nutrients to drain downslope within local groundwater, ultimately entering the lake.

TW should be contacted to seek assurance that the operational issues that result in sewage spillages entering the lakes will be addressed. Not only is sewage damaging to the ecology of the water via possible de-oxygenation and elevation of nutrient levels, they can also be directly harmful to human health; sewage contains a range of potentially dangerous pathogens. TW may also be able to provide funding for a community project such as that at Adderbury lakes. Projects that enhance biodiversity, education and community engagement are favoured by TW. The community contact at TW is Rosemary Waugh [rosemary.waugh@thameswater.co.uk](mailto:rosemary.waugh@thameswater.co.uk)
